# IAC News : Special Issue No.10

## Quick Report on the 2016 Kumamoto Earthquake

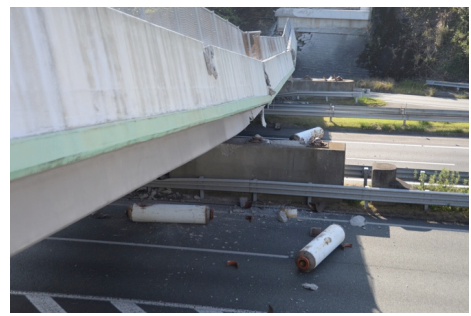
damaged, and beams were displaced from the bearings, causing an uneven road surface. Also, several overbridges were damaged. The Furyo Overbridge collapsed onto the expressway following the main shock early on the morning of April 16 (Photo 1).

Photo 1: Collapse of Furyo Overbridge onto the Kyushu Expressway

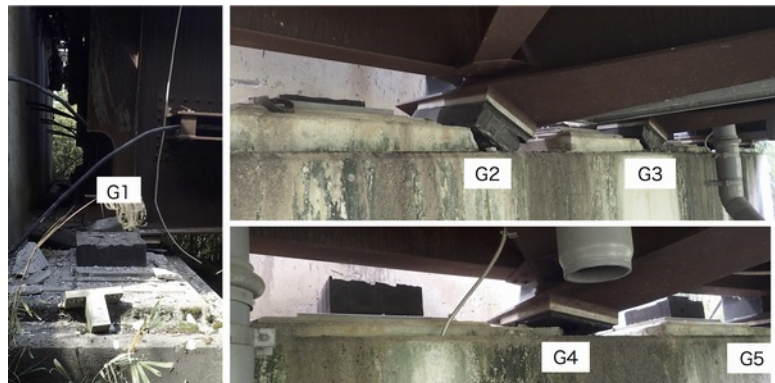
Great Hanshin-Awaji Earthquake. On the Okirihata Bridge, which is a five-span continuous bridge, rubber bearings were broken at every abutment and pier, except for one pier (Photo 2), and as a result, beams moved in the bridge-axial rectangular direction, and reinforced concrete bridge piers with unbroken bearings suffered bending damage. Additionally, on the Tawarayama Bridge, there was displacement of beams from the rubber bearings and buckling of steel beams.

Photo 2: Abutment of Okirihata Bridge with broken rubber bearings

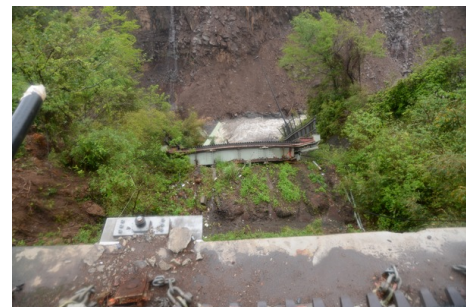
In the Minamiaso area, the Aso-Ohashi Bridge collapsed and was carried away downstream due to slope failure (Photo 3). On the Minamiaso Bridge, which had been reinforced against earthquakes with dampers, parts mounted with dampers working in the bridge-axial direction were damaged.

Photo 3: Collapse of Aso-Ohashi Bridge due to slope failure

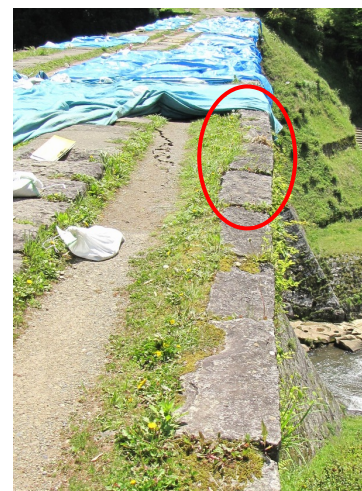
These two earthquakes, the foreshock and the main shock, both of which had a seismic intensity of 7, devastated many of the stone bridges in Kumamoto Prefecture and the ruins of Kumamoto Castle. These included the Tsujunkyo Bridge (constructed in 1854), which is a nationally important cultural property, the Nagayama Bridge (1878) and Tatekado Bridge in Kikuchi City, which are designated as cultural property by Kumamoto Prefecture, and the Yasemegane Bridge (1885) and Monzengawamegane Bridge (1808) in Mifune Town, which are also designated as cultural property by Kumamoto Prefecture. On these bridges, stone walls collapsed and arch stones were damaged. On the face of the Tsujunkyo Bridge, a significant number of cracks with a width of 5–10 cm occurred in the covering soil between the stone wall and the stone

Photo 4: Deformation of the upper part of the stone wall of Tsujunkyo Bridge

pipe portion, and as a result, the upper part of the stone wall swelled outward (red circle in Photo 4). It was also found that gaps had developed at many of the joint parts of the stone water pipes, and extensive damage and flaking were found in the plaster parts, indicating possible water pipe damage. These findings show that further investigation is needed to clarify the damage status of the water pipes. The photos of Shimotsuru Bridge (Uki City, Photo 5) show the collapse status of the masonry wall and bridge railings (Photo above), the wide gaps that developed between the arch stones and the cracking of those stones (Photo below). The development of gaps between the arch stones was found to be very similar to the arch stone behavior observed in a vibration experiment using an arch stone model. According to the report, however, the collapse of arch stones did not occur in these major earthquakes. Typical types of damage include collapse and swelling of stone walls and falling of bridge railings. On the other hand, major damage occurred in the ruins of Kumamoto Castle (Fig. 3) including the complete collapse of Kitajuhachiken-Yagura, Higashijuhachiken-Yagura, Goken-Yagura, Akazunomon and Nagabei, which are nationally

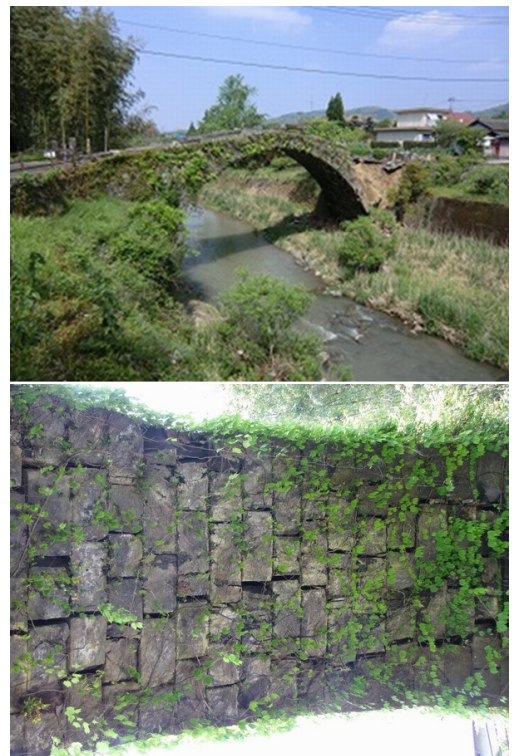
Photo 5: Collapse status of the masonry wall of Shimotsuru Bridge (Uki City) and gaps that developed between the arch stones

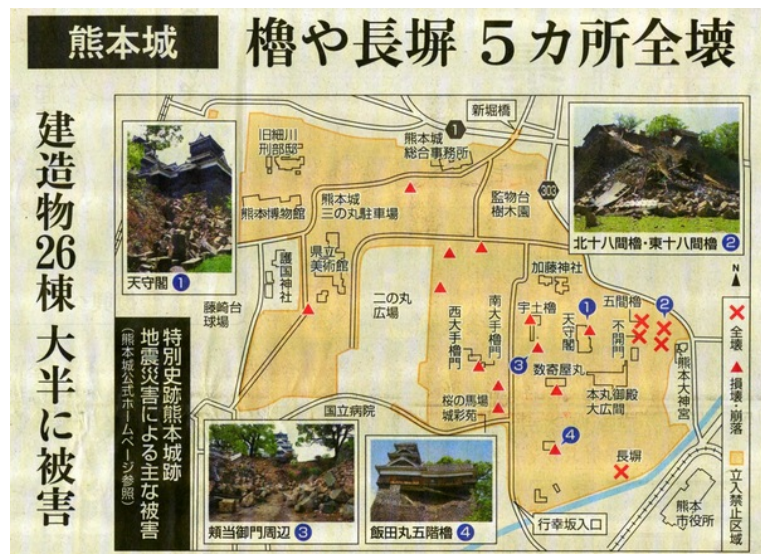
important cultural property, damage to 26 structures such as turrets (yagura) and gates, and the collapse of stone walls. Damage was found at 52 locations, and much of it was caused by the main shock.

Fig. 3: Major damage to the ruins of Kumamoto Castle (Article from May 8 Morning Edition of Kumamoto Nichi Nichi Shimbun)

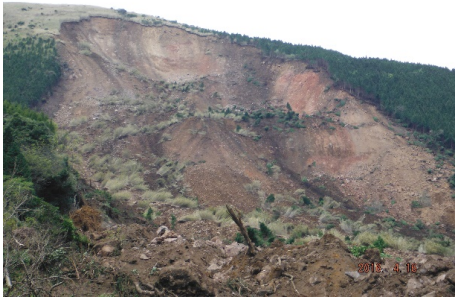
Photo 6: Large-scale slope failure that caused the collapse of Aso-Ohashi Bridge

The landslide disasters in the earthquake were mostly characterized by ground collapse at areas where the surface layer consisted of volcanic ash soil. The following are major examples of the collapse: (1) It is assumed that large-scale slope failure (deep-seated landslides) (Photo 6, 7) occurred when a massive vibration hit the slope that had a weak plane, which had formed under the influence of weathering acting on the lava with cracks developed in the surface layer of volcanic ash and the basement stratum. Since the upper part of the area where the collapse occurred was steeply inclined, the massive vibration hitting that part caused cracking, leading to the collapse of the surface layer. It is considered that this collapse caused the collapse of the weathered lava layer, which is believed to have supported the surface layer, thus resulting in the large-scale collapse. (2) This was the collapse of a slope with a gradient of less than 20° (Photo 8). There was a very weak stratum (Photo 9), which had formed through the argillation of pyroclastic fall material, beneath the relatively thick volcanic ash soil layer (kuroboku soil/akaboku soil). When hit by the massive vibration, the weak stratum became fluidized and slid off a flattened basement stratum, the Kusasenrigahama pumice layer, resulting in a large-scale mass failure. It is considered that this was the collapse of volcanic ash soil layers and pyroclastic fall material including very few boulders. (3) As shown in the surface failure on Mt. Eboshidake (Photo 10), in the area around the central cone, volcanic ash soil layers of the steeply inclined slope collapsed in a continuous manner, resulting in a great amount of collapsed sediment. Some of the soil fell into mountain streams and caused mud avalanches; however, most of the soil fell into streams and remained there (Photo 11), raising concerns about more disastrous mud avalanches after a heavy rain or intense rainstorm during the rainy or typhoon seasons in the future. Furthermore, in any type of slope collapse, large cracks are found on the top or side of the upper parts of the area where the collapse occurred, which shows that further slope collapse can take place at any time. (4) As shown in the picture of the road leading to Aso Choyo Ohashi Bridge, roads collapsed and were damaged (Photo 12). This road collapse appears to have been caused by the collapse of volcanic ash soil on lava, since the inclination of the collapsed part is gentle. Also, collapse and damage of the road constructed in the steeply inclined area near Aso Choyo Ohashi Bridge were remarkably severe (Photo 13).

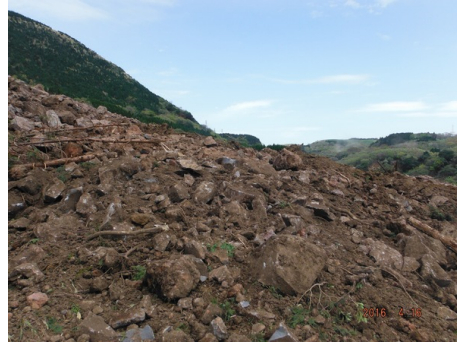
Photo 7: Collapsed sediment and rock mass deposited on gently inclined area

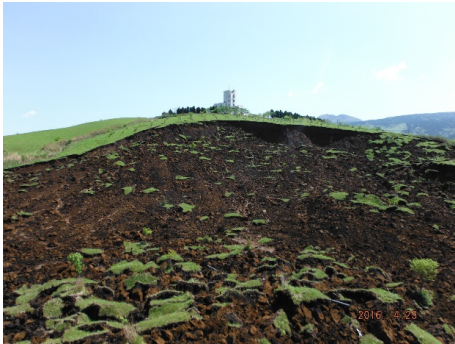
Photo 8: Surface failure that occurred on a gently inclined slope

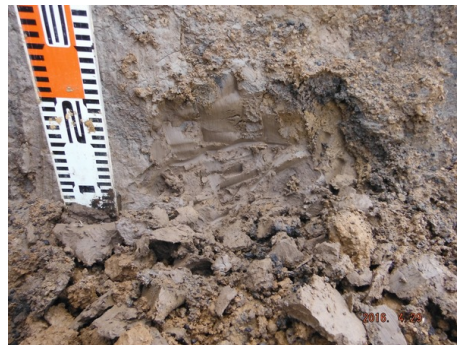
Photo 9: Weak argillaceous stratum, the layer that caused the landslide, had formed in the lower part of the akaboku soil stratum. The Kusasenrigahama pumice fall deposit can be seen under this layer.

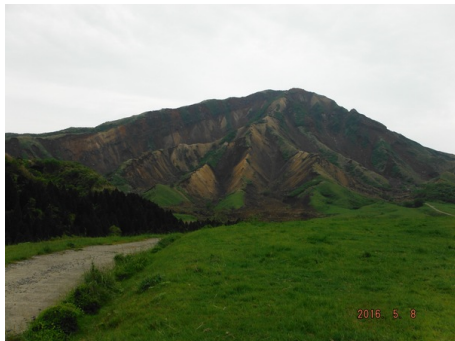
Photo 10: Surface failure on the south slope of Mt. Eboshidake

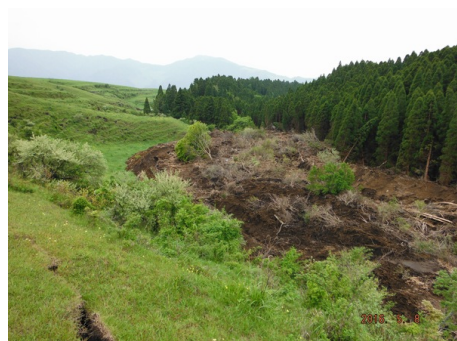
Photo 11: Collapsed sediment blocked the outlet of a valley, downstream of which is the Sannodani River.

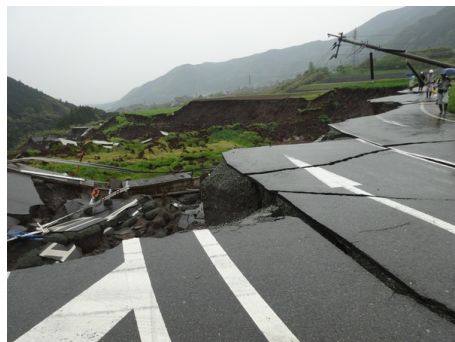
Photo 12: Collapse of the road leading to Aso Choyo Ohashi Bridge

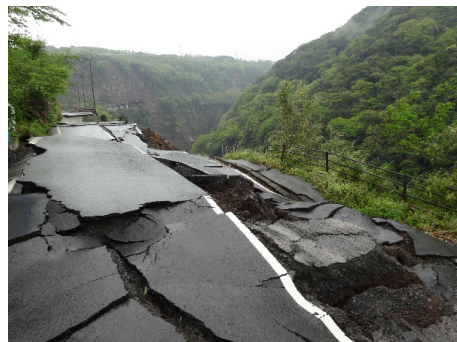
Photo 13: Damage and collapse of the access road connected to the Aso Choyo Ohashi Bridge

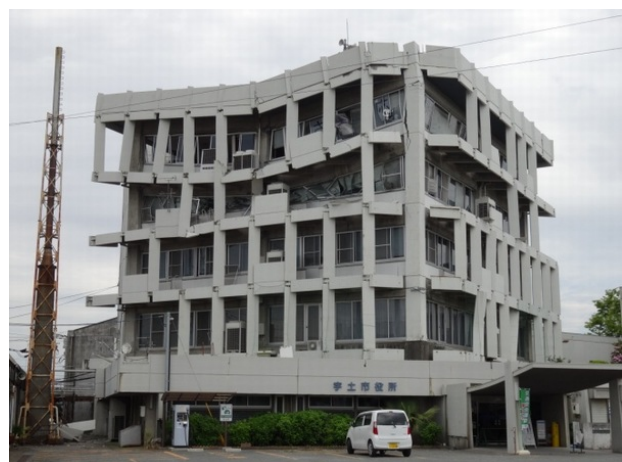
City halls and town halls, which can also serve as disaster-prevention centers, became unusable. Photo 14 shows the city hall building of Uto City, in which the fourth floor of the five-story building nearly collapsed. Also, Yatsushiro City Hall, Hitoyoshi City Hall, Mashiki Town Hall and Ozu Town Hall became unusable and could not serve as disaster-prevention centers. Additionally, foundation hospitals including Kumamoto City Hospital were not able to take critical-care patients due to damage to buildings and interruption of electricity, gas and water supply, which brought about confusion at medical sites. Such damage to the disaster-prevention centers hindered assistance for those affected.

Photo 14: City hall building of Uto City
