Natural Disaster and Countermeasure in Taiwan

Jaw-Lieh Wang

5th Sep. 2012

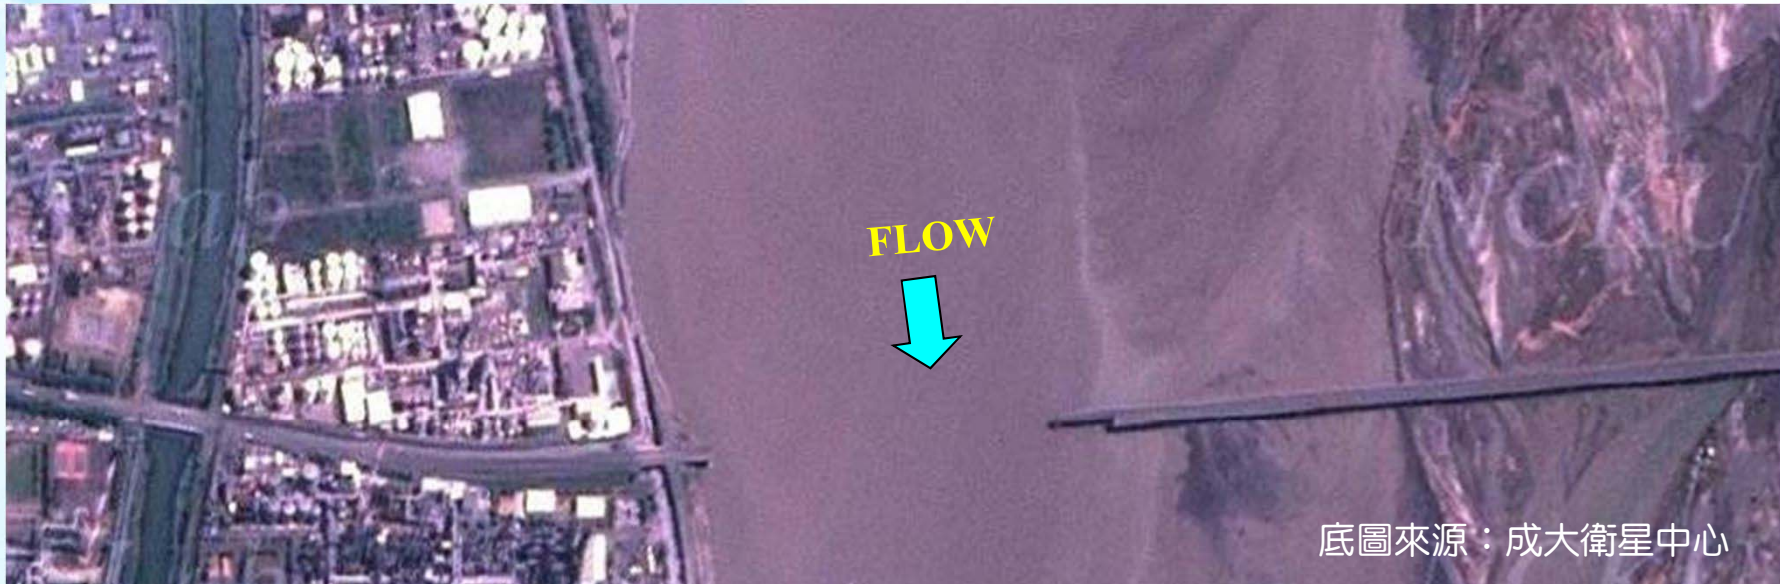
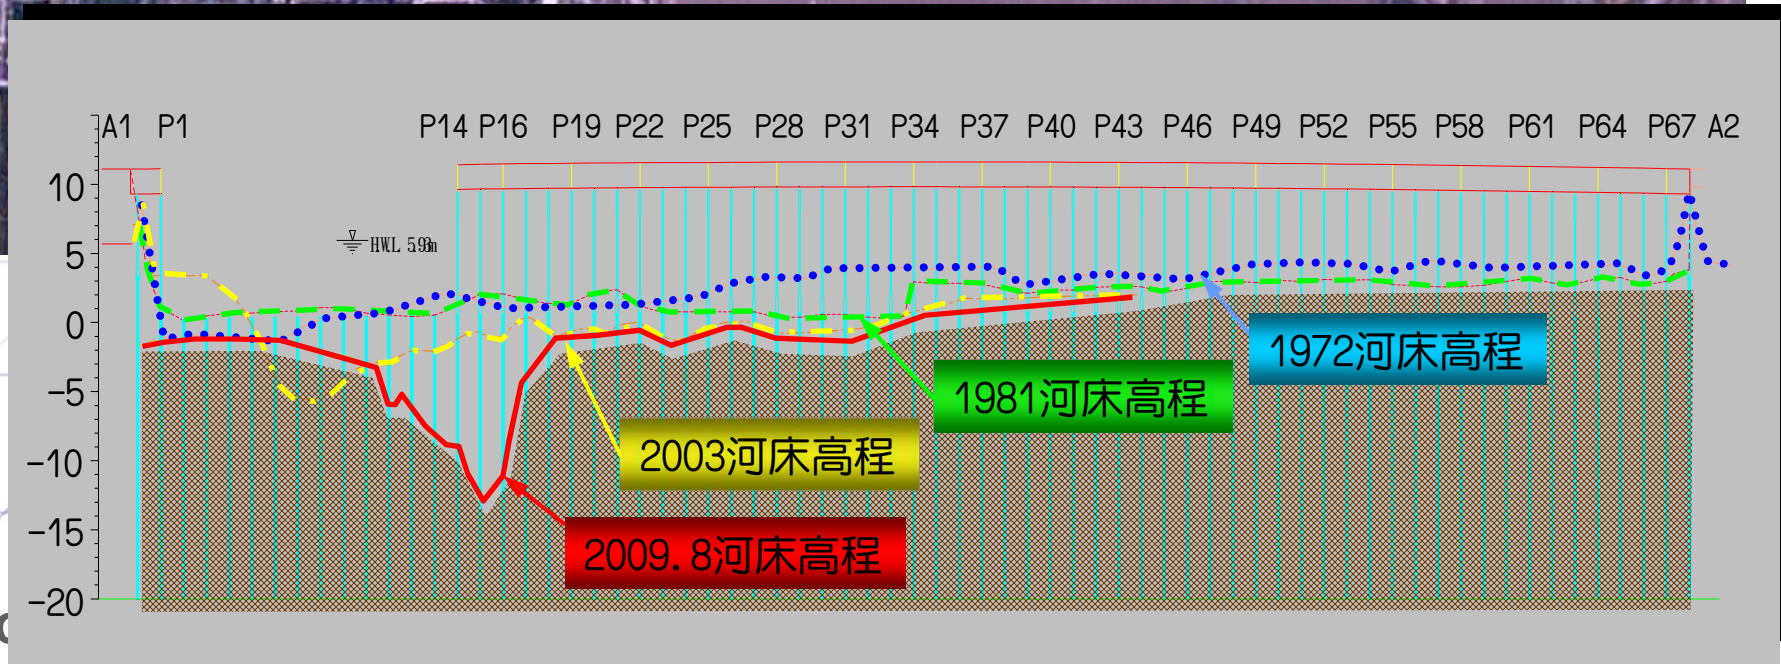
Scouring and collapsed of Swan-Yuan bridge caused by Morakot typhoon

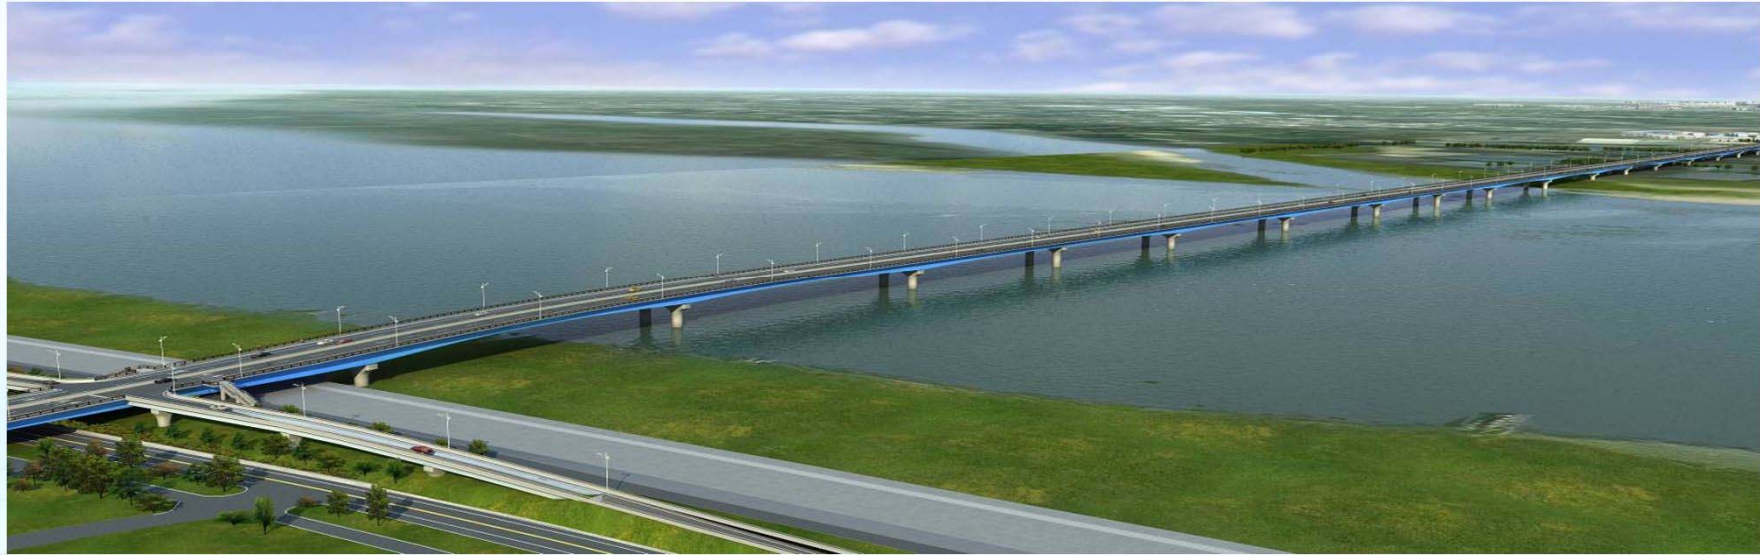
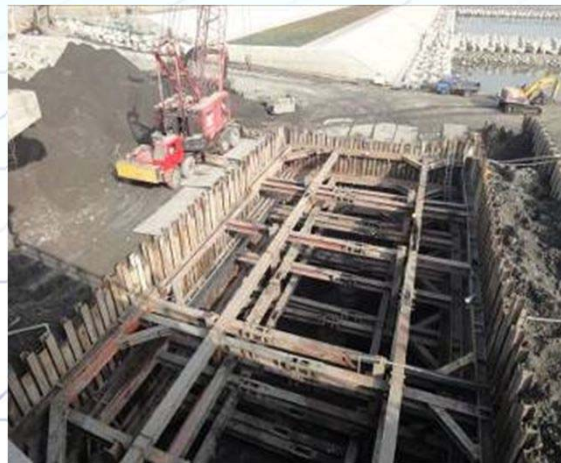
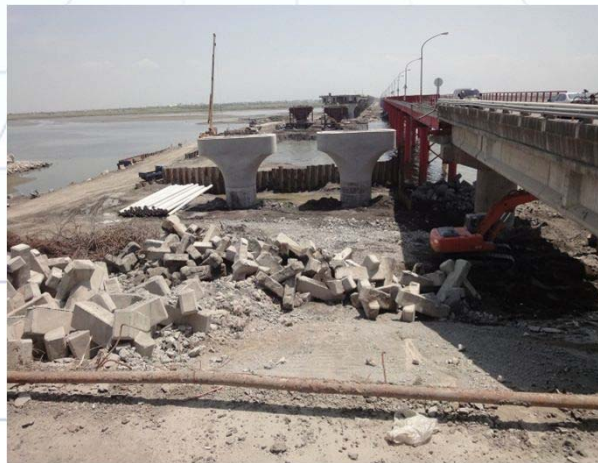
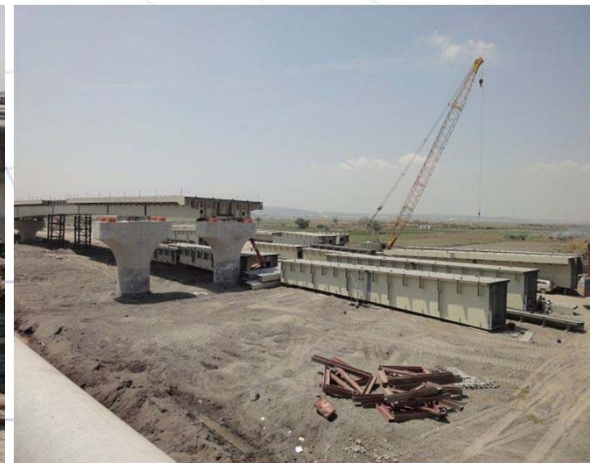
Reconstruction of Swan-Yuan bridge after Morakot

- Large span length, less piers for rebuilt and new-built bridge, scenical bridge integrated with local landscape
- Pier location avoid deep river channel
- Stream-flow pier shape
- Increase the anti-flood ability for structure
- For unstable river, increase the pile length and a allowable free standing length for scouring

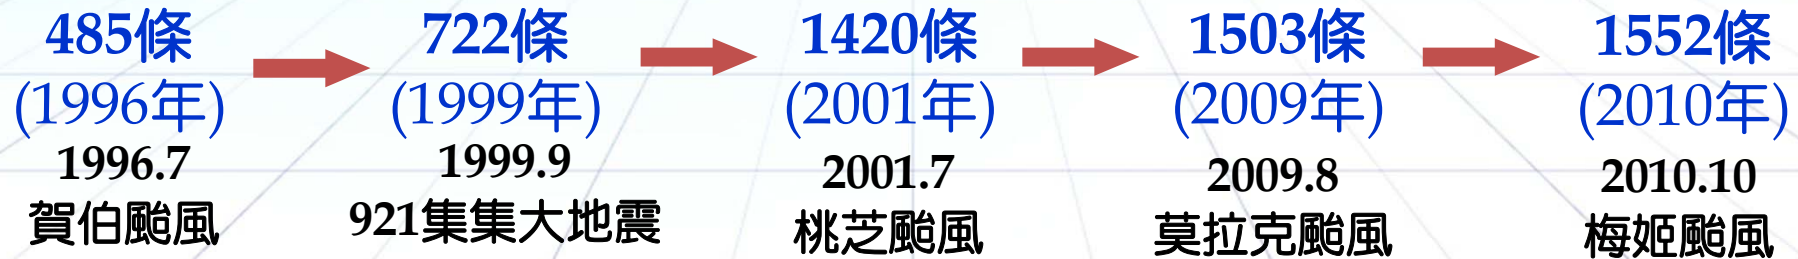
Dangerous Rivers in Taiwan

- ▶ Investigation in 1996, 485 rivers have high potential of debris flow, and it became 722 rivers after Chi-Chi earthquake in 1999. And there are 1,503 after Morakot typhoon in 2009.
- ▶ Sediment mass leave after earthquakes and typhoons, debris flow occurs when rainfall of more than 40mm or 150mm

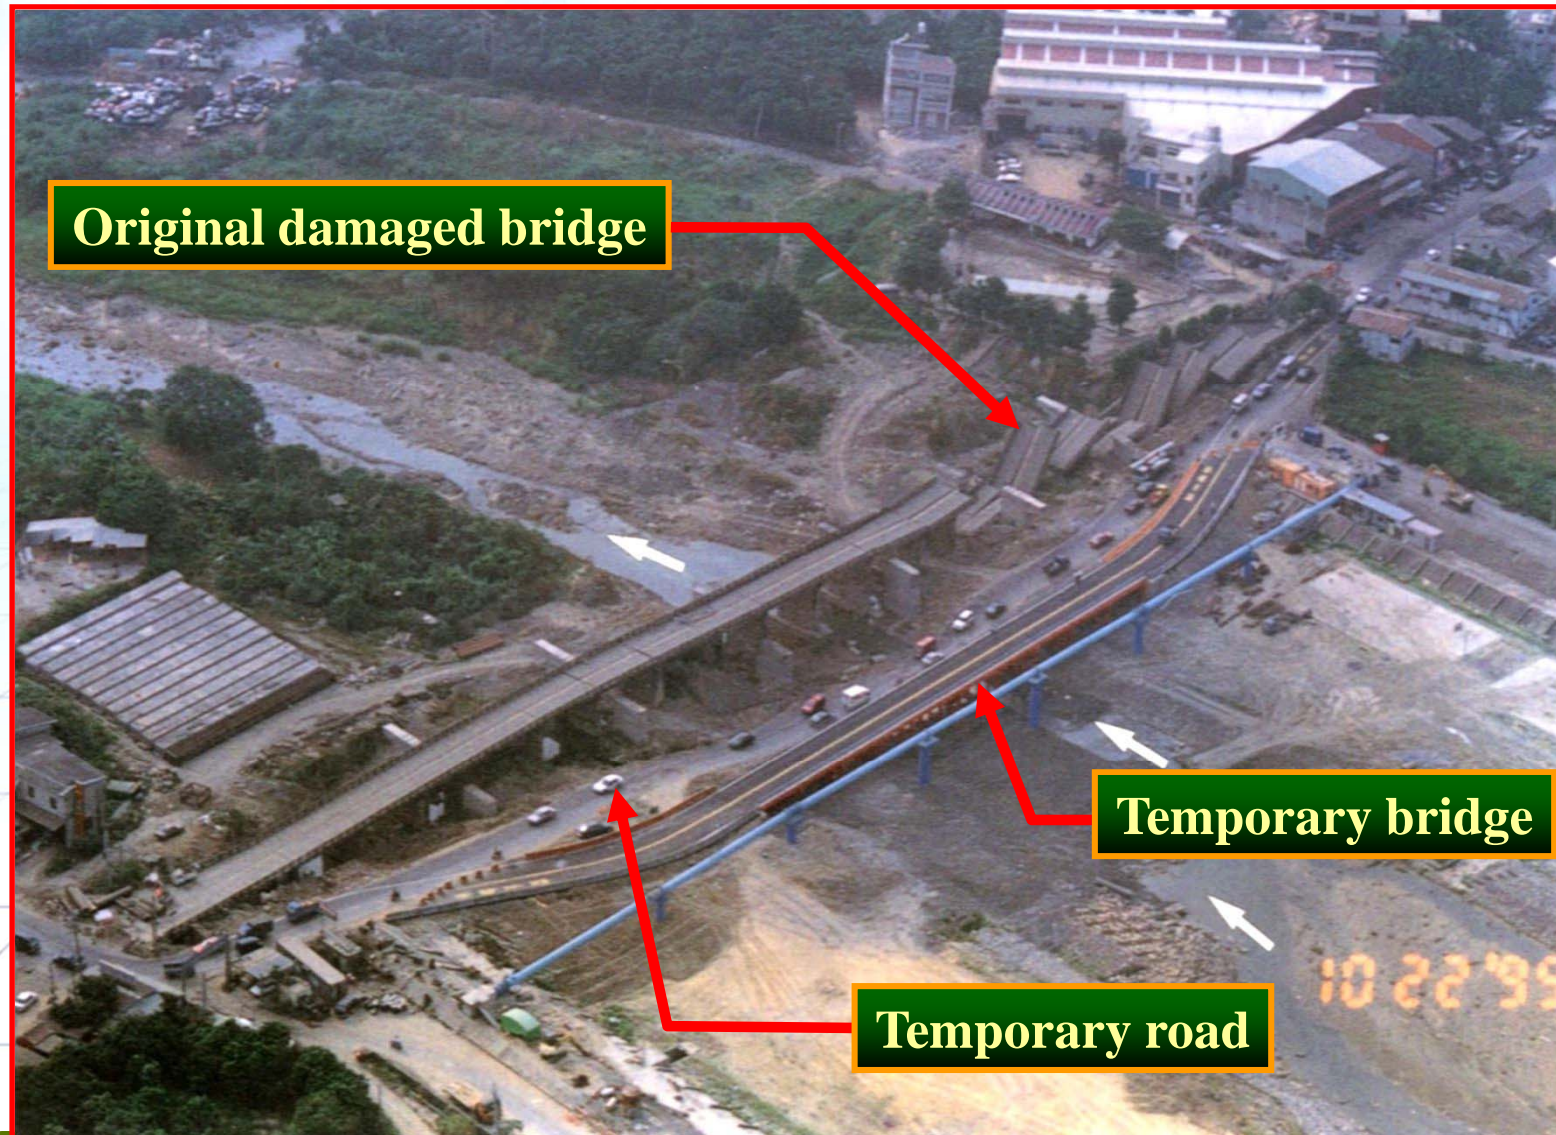
E-Jiang Bridge's temporary traffic after Chi-Chi (921) earthquake
