## IAC News No.50

### Quick Report on the 2016 Kumamoto Earthquake ※

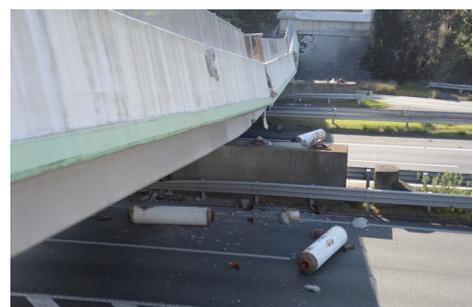
Photo 1: Collapse of Furo Overbridge onto the Kyushu Expressway

deformation as well as by strong seismic motion. On the Kyushu Expressway, which runs through plains, the elevated bridges that had not been reinforced against earthquakes were severely damaged, and overbridges collapsed onto the expressway following the main shock (Photo 1). In the mountainous regions, major damage such as breakage of laminated rubber bearings and displacement of beams from the bearings occurred on several bridges with displacement constraints based on the specifications revised after the Hyogoken-Nanbu Earthquake, and an arch bridge was completely destroyed by a large-scale slope failure.

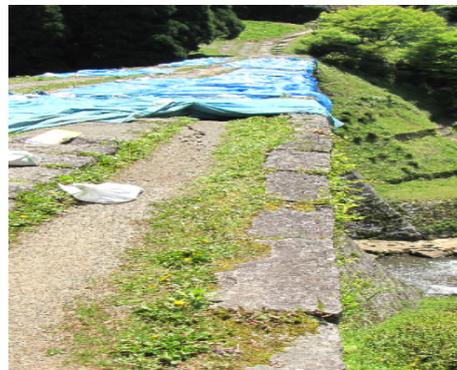
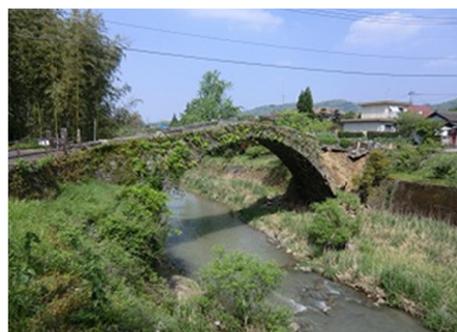
Photo 2: Deformation of the upper part of the stone wall of Tsujunkyo Bridge (above) and collapsed masonry wall of Shimotsuru Bridge (Uki City) (below)

The earthquake devastated many of the stone bridges in Kumamoto Prefecture and the ruins of Kumamoto Castle, which are designated as cultural property. On the Tsujunkyo Bridge (Photo 2 above), cracking of the covering soil between the water pipes, displacement of the joint parts of the water pipes and outward swelling of the upper part of the stone wall occurred. Other examples of the damage to stone bridges include that of Shimotsuru Bridge (Photo 2 below), in which half the stone wall and bridge railings collapsed. As shown in this case, stone bridges typically suffered collapse, swelling of stone walls and falling of bridge railings. In the ruins of Kumamoto Castle, 23 turrets and gates including Kitajuhachiken-Yagura, Higashijuhachiken-Yagura, and Nagabei, which are designated as nationally important cultural property, and stone walls were damaged; the number of damaged locations reached as many as 50.

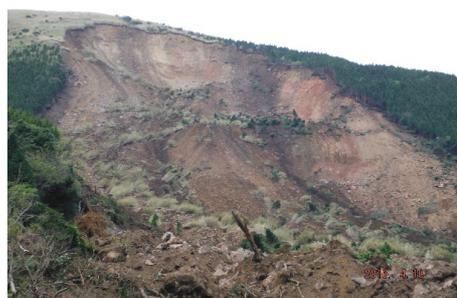
Photo 3: Large-scale slope failure that caused the collapse of Aso-Ohashi Bridge

Many of the landslide disasters in the 2016 Kumamoto Earthquake were characterized by ground collapse at areas where the surface layer consisted of volcanic ash soil. The following are typical examples. (1) Large-scale slope failure (deep-seated landslide) (Photo 3): Since the upper part of the area where the collapse occurred was steeply inclined, the massive vibration hitting that part caused cracking, leading to the collapse of the surface layer. It is considered that this collapse caused the collapse of the weathered lava layer that is believed to have supported the surface layer, thus resulting in the large-scale collapse. (2) Collapse of a slope with a gradient of less than  $10^\circ$  (Photo 4): When the massive vibration hit the very weak stratum formed through the argillation of pyroclastic fall material beneath a thick volcanic ash soil layer, the weak stratum became fluidized, which resulted in a large-scale landslide. This was the collapse of volcanic ash soil layers and pyroclastic fall material. (3) Surface failure: As shown in the surface failure on Mt. Eboshidake, in the area around the central cone, volcanic ash soil layers of the steeply inclined slope collapsed in a continuous manner. Part of the collapsed sediment was deposited in mountain streams, causing mud avalanches. (4)

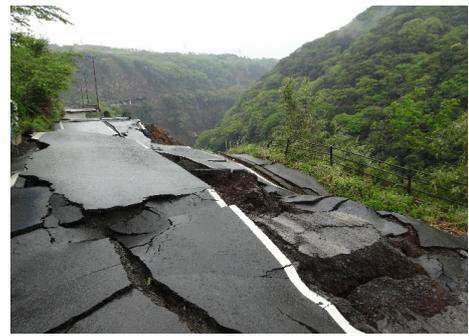
Photo 5: Damage and collapse of the access road connected to the Aso Choyo Ohashi Bridge

Damage and collapse of roads (Photo 5): On the road leading to the Aso Choyo Ohashi Bridge, road damage and collapse occurred. This road collapse appears to have been caused by the collapse of volcanic ash soil on lava, since the inclination of the collapsed part is gentle. Also, collapse and damage of the road constructed in the steeply inclined area near Aso Choyo Ohashi Bridge were remarkably severe. Since deformation such as cracking has developed in some places of the slopes in the areas hit by the intense quakes, it is necessary to stay on the alert against the occurrence of slope collapse.

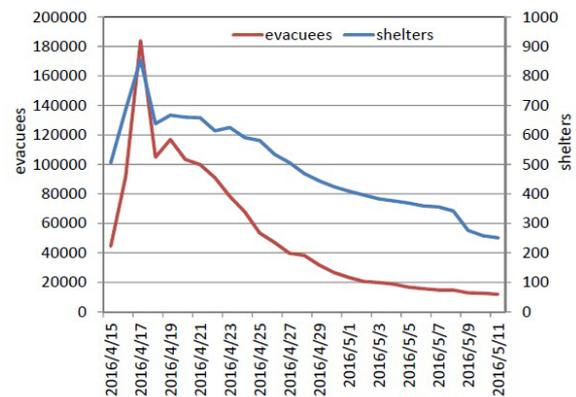
Fig. 1: Changes in the number of evacuees and shelters

However, as shown in Fig. 1, with the recovery of lifelines including water, gas and electricity supply, the number of evacuees gradually decreased, highlighting the importance of seismic retrofitting of lifelines.

The earthquakes on April 14 and 16 also caused severe damage to lifelines such as electricity, gas and water supply. About 200,000 households temporarily lost power, and as of the night of April 16, about 80,000 households were still without power, which was recovered by April 20. Regarding water supply, up to 370,000 households were without water until one week later when water could be supplied to 90% of the households; however, about 4,000 households were still without water as of May 10. City gas supply was suspended to about 100,000 households, but was gradually restored from April 20 and then completely restored by the end of April. In the 2016 Kumamoto Earthquake, the number of evacuees reached 180,000, which decreased slowly due to the recurring aftershocks. However, as shown in Fig. 1, with the recovery of lifelines including water, gas and electricity supply, the number of evacuees gradually decreased, highlighting the importance of seismic retrofitting of lifelines.

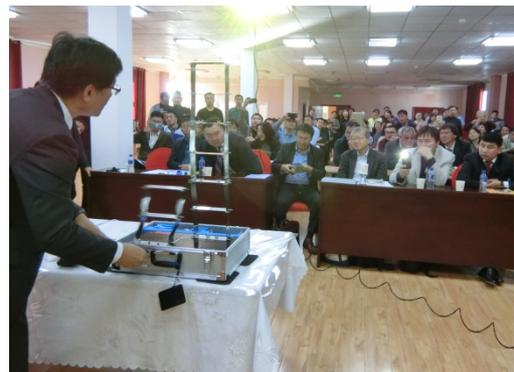
The author explains resonance by using shaking building models

The technical lecture covered earthquake hazard evaluation, business continuity plan, seismic static lateral force, seismic evaluation and strengthening methods, seismic isolation and response control methods, and a shaking table facility. The speaker explained those topics by using motion videos and shaking building models. In a Q&A session, he responded to the questions about the cost-effectiveness of seismic isolation and response control methods, maintenance costs, earthquake countermeasures for precast concrete structures, and designing earthquakes for high-rise buildings. Finally, Mr. B. Gunbold, President of MACE, gave a closing address.
