Japan Society of Civil Engineers
International Activities Committee
Newsletter

No. 36, February 2012

The Earthquake Damage and the Restoration Status of the Railway Facilities of JR East Japan

The Construction of Tokyo Sky Tree,
A Challenge to the height by human
– New landmark tower in Tokyo –

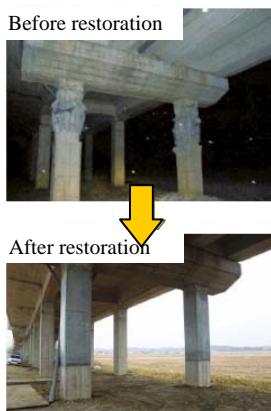
Photo 1: Damage on viaduct pillars (Mizusawa-esashi – Kitakamima)

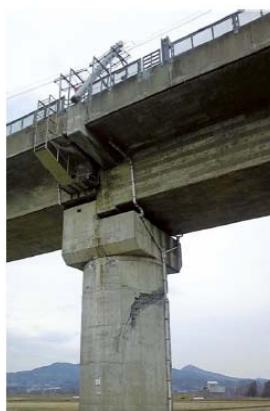
Photo 2: Damage on a bridge pier (Ichinoseki – Mizusawa-esashi)

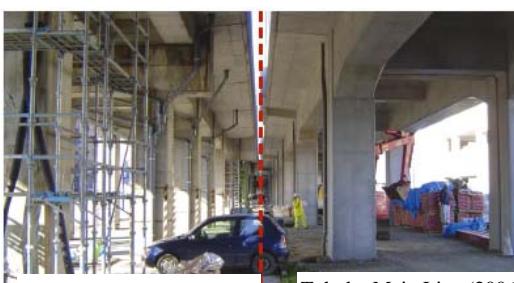
Photo 3: Damage on viaduct pillars (Shiraishi-zaou – Sendai)

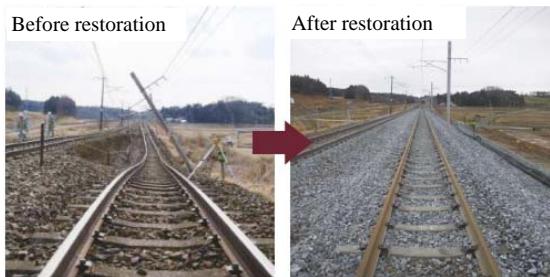
Photo 8: Failure of an embankment slope (Tohoku Main Line, Umegasawa – Nitta)

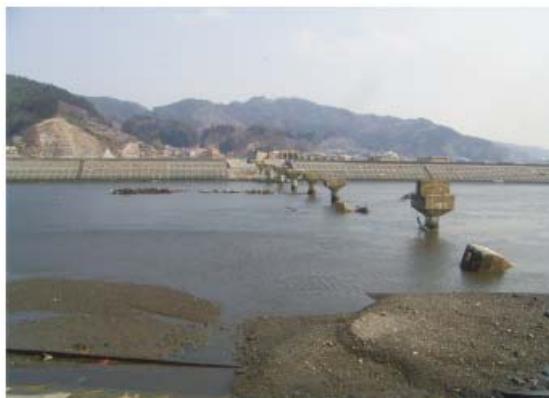
Photo 9: A bridge girder washout by the tsunami (Yamada Line, Kirikiri – Otsuchi)

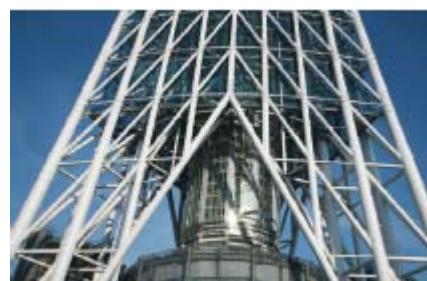
And thirdly, the "Slip-form method" by which the reinforced concrete center column is constructed efficiently in parallel with the construction of gain towers.

Photo 2:
Inside of the central
pillar under
construction

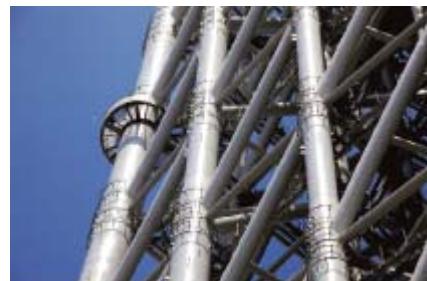
Tokyo Sky Tree (Project implementing body: Tobu Railway, Tobu Tower Sky Tree) is a very slender tower with a width-height proportion ratio of 3.9: the foot width 68 meters to the height, 634 meters. Its structure style is a hybrid structure consisting of the center column made of reinforced concrete and the tower body made of steel truss, employing the center column vibration control, which controls joint vibration

Photo 3:
Truss structure

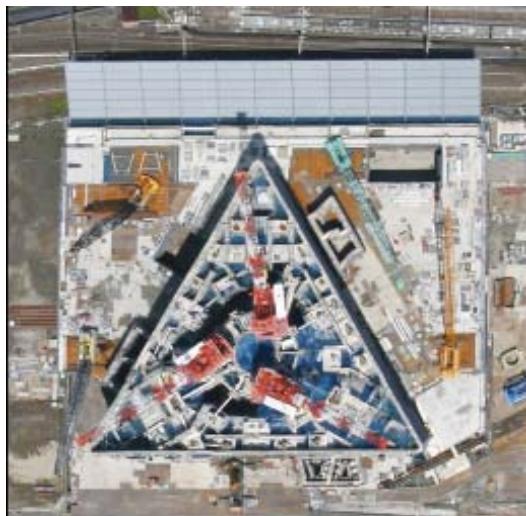
Photo 7: Air photo of the tower foot construction
(June 7, 2009)

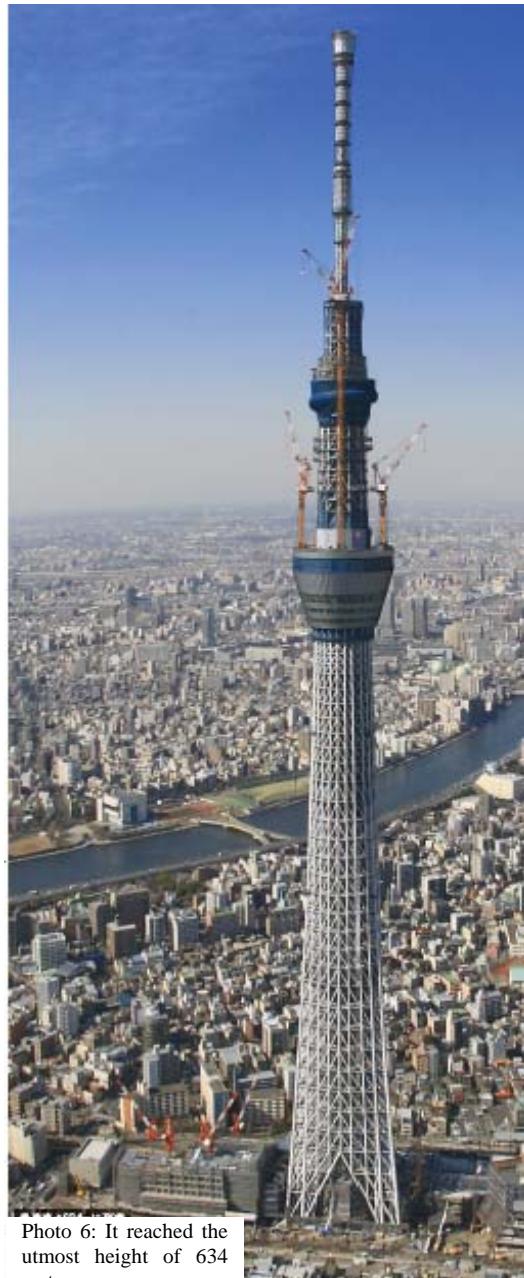
Photo 6: It reached the utmost height of 634 meters

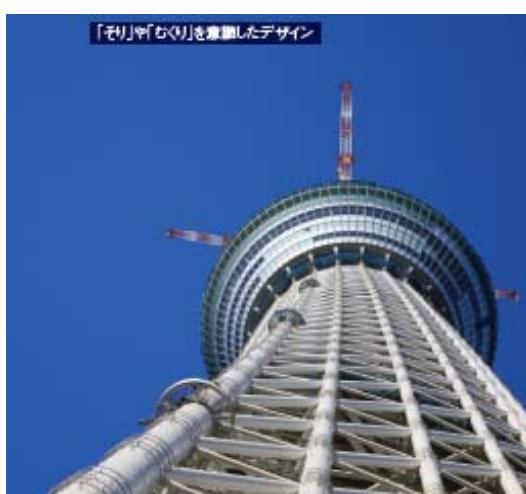
Photo 8: The design where the "sori" (concave curves) and "mukuri" (convex curves) were consciously intended.
