PRESENT STATE OF METROPOLITAN EXPRESSWAY (MEX) – 1/2

SEVERE USAGE OF MEX

INSPECTION & REPAIR FLOW

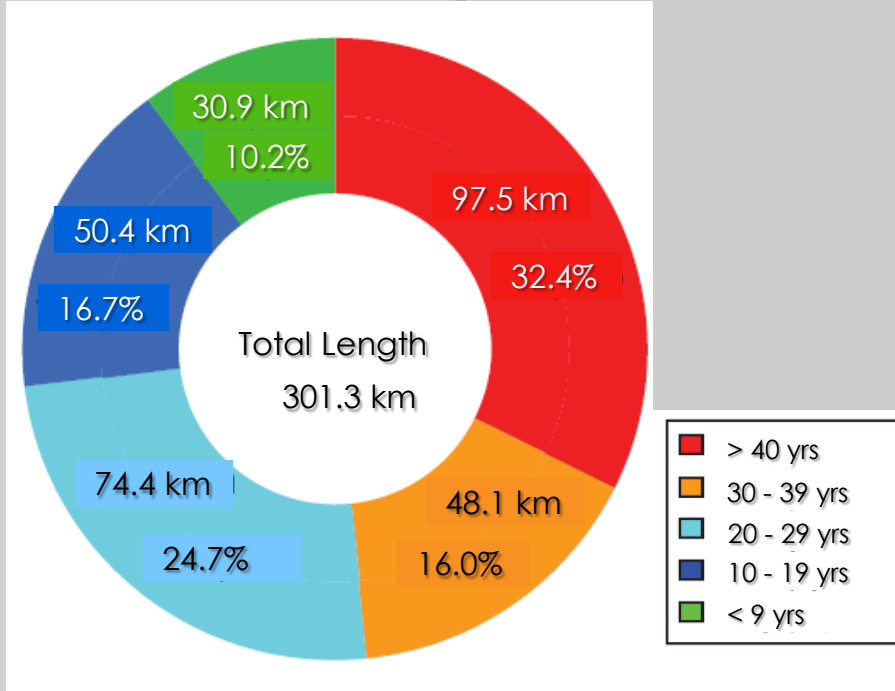
Years in Service and Ratios (As of April 2012)

Structural aging is spreading, where ones' above 40 years occupies more than 30% (approx. 100 km in length) and above 30 years does nearly 50% (approx. 145 km) to the whole.

Years in Service (As of April 2012)

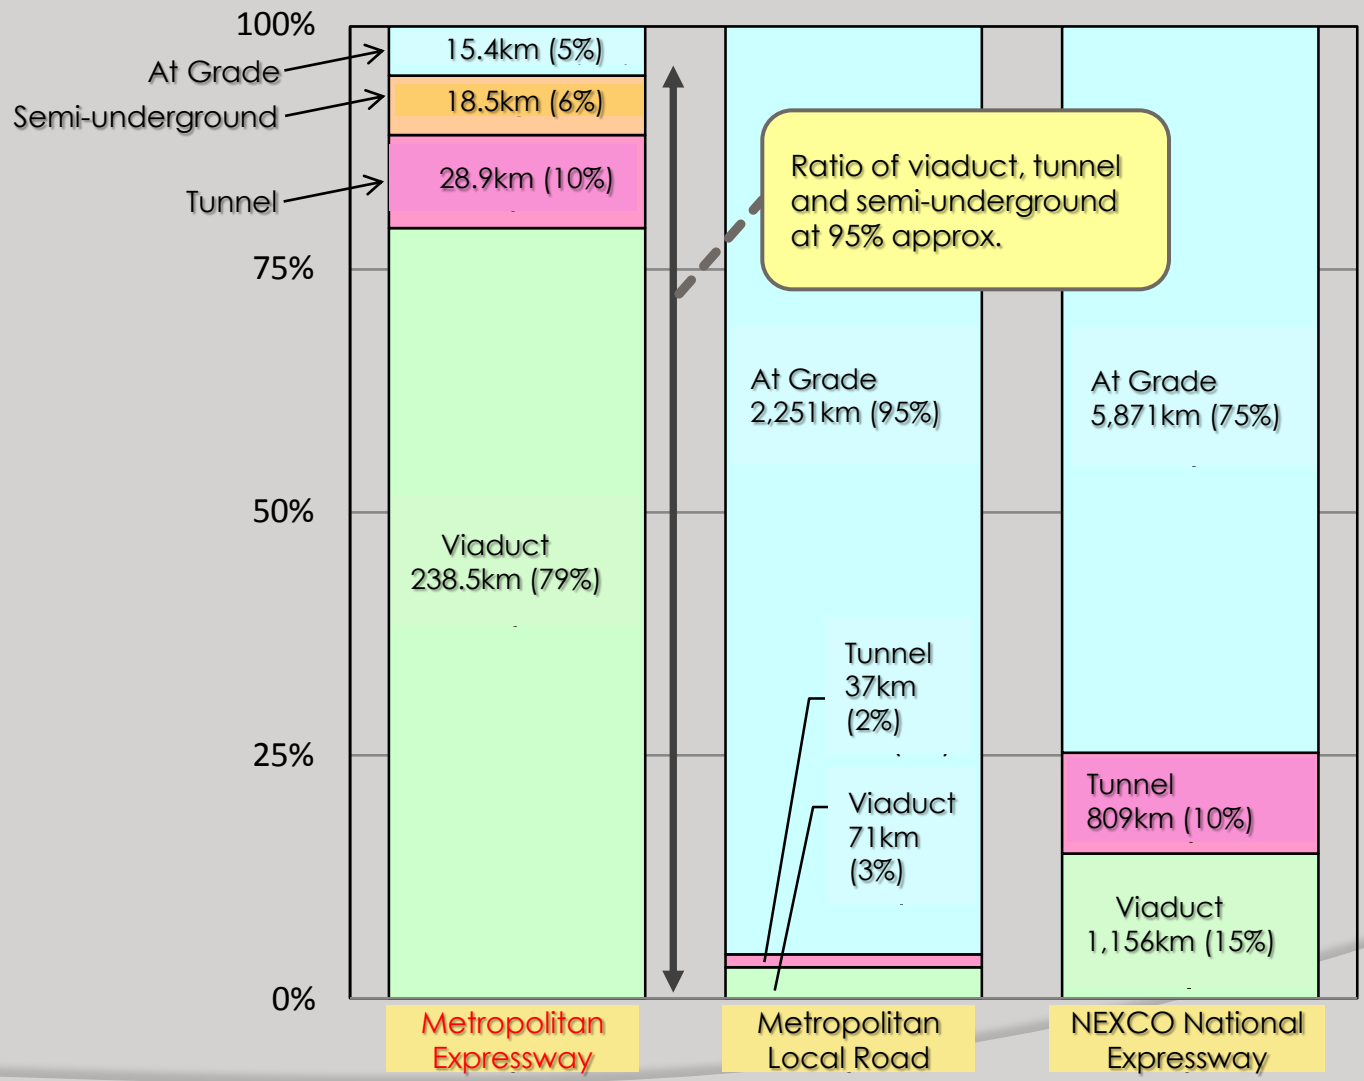
Structural Type Ratio as of:
 Metropolitan Expressway – Apr 2012
 Metropolitan Local Road – Apr 2007
 NEXCO National Expressway – Apr 2012

Structural type of viaducts, tunnels and semi-underground take up the majority with very high ratio at 95% to require much time and energy for maintenance.

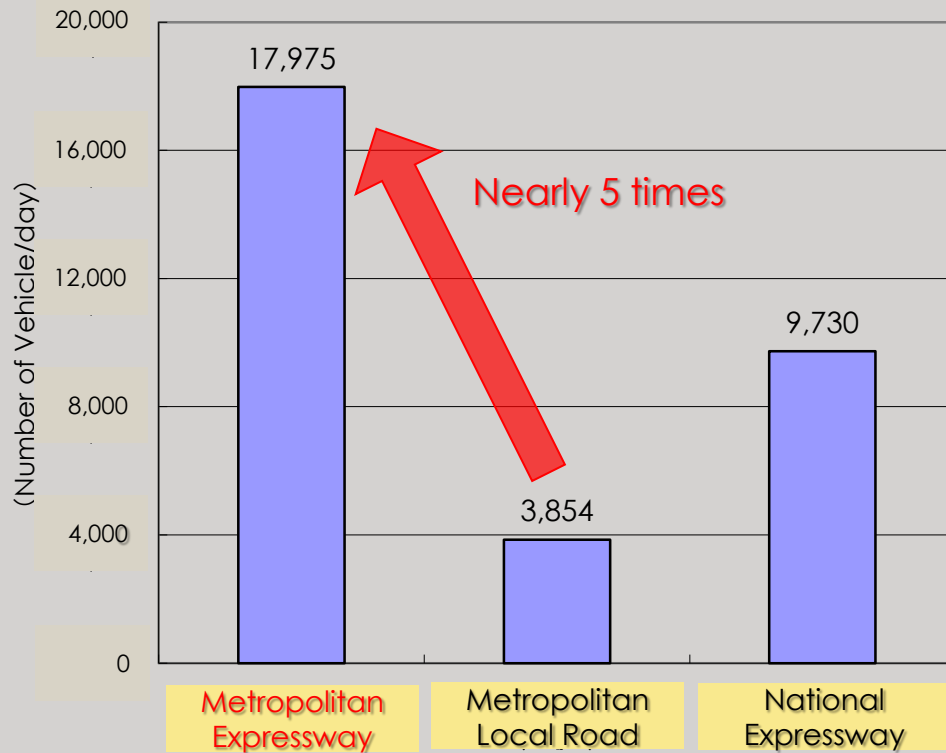
Heavy Vehicles' Usage Comparison

- In addition to high ratio of aged structure, heavy vehicles' usage counts 5 times of metropolitan local roads'.
- Annual traffic violation by over-loading counts approx. 350,000.

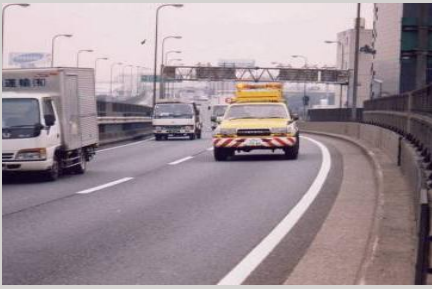
Patrol Inspection

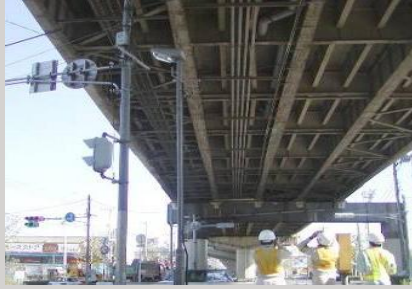
Walk-around Inspection

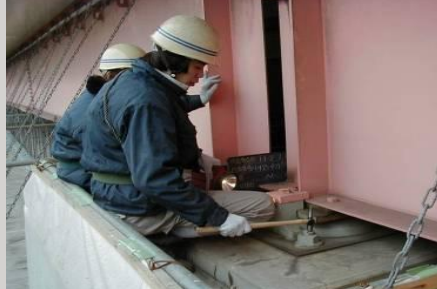
Close Inspection from Suspended Platform

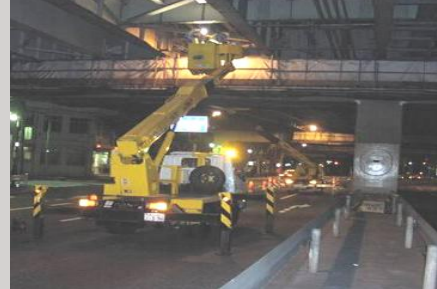
Close Inspection from Lifted Platform

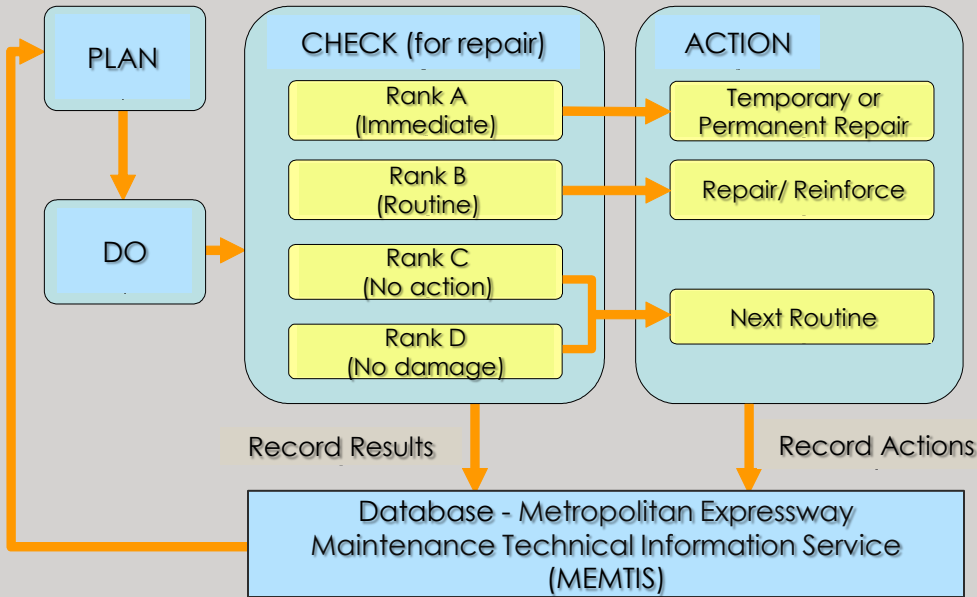
- Exercise PDCA cycle for structural inspection and repair
- Implement damage assessment for ranking into A to D categories
- Carry out immediate repair on Rank A damages
- Do routine repair on increasing Rank B damages

| Rank A | Immediate repair needed to prevent damages to public etc. |
| Rank B | Programmed routine repair needed |
| Rank C | No need for repair but damages be recorded |
| Rank D | No damages but inspection be recorded |

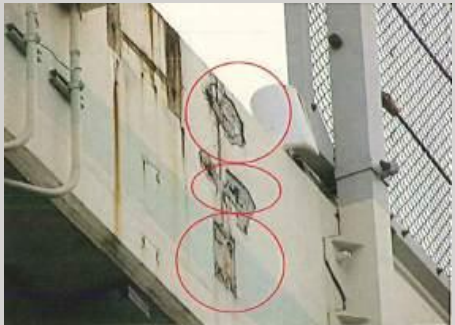
Flaking

Examples of Repairs on Rank A (Immediate Repairs)

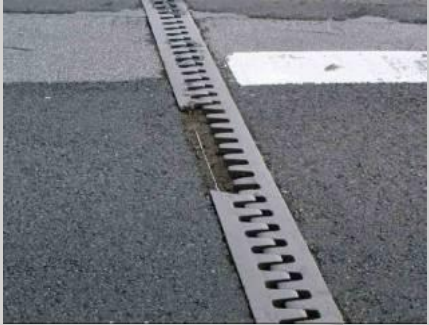
Broken Joint

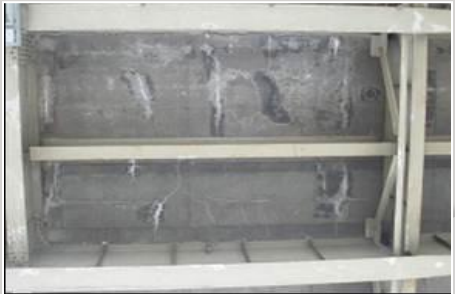
Cracks on Slab

Examples of Repairs on Rank B (Routine Repairs)

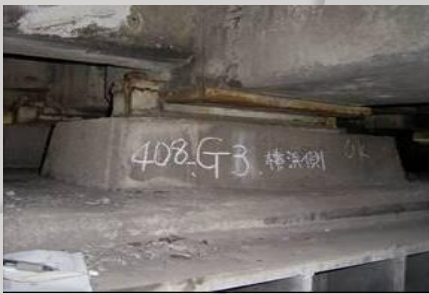
Corroded Bearing

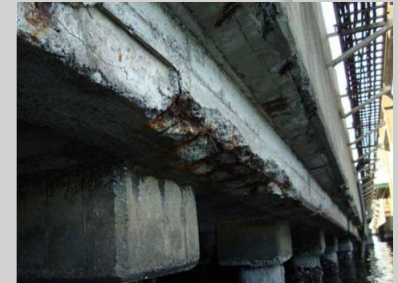
Route 1 Haneda Line – Higashi Shinagawa Viaduct (Marine Section)

Examples of Section for Potential Renewal

Flaking Caused by Rebar Corrosion
