MULTI-METHOD APPROACH FOR UNDERGROUND UTILITY ASSESSMENT: COMBINING GROUND PENETRATING RADAR AND ELECTRICAL GEO-RESISTIVITY SURVEY

Maria Sophia R. Orticio

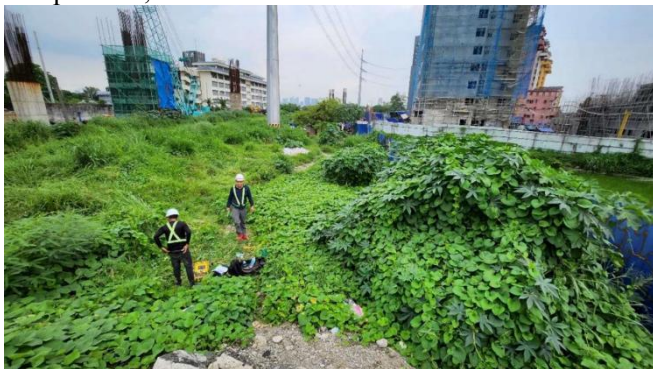
Figure 2.1.2.1 Estimated Pipeline alignment (center). Excavation site of affected property with water accumulation is visible on the right, and the Railway with transmission line on the left. Photo taken from the top of the backfill stockpile prior to removal.

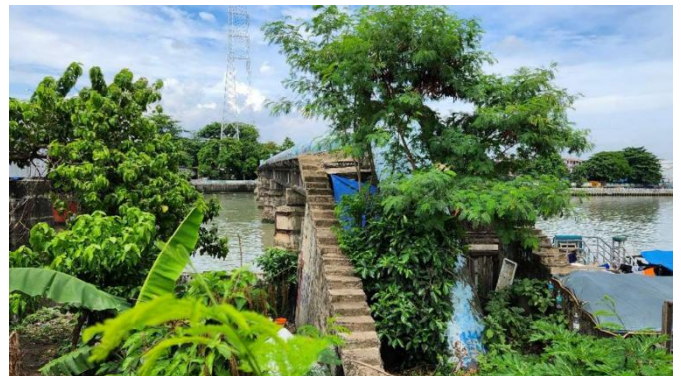
Figure 2.1.2.2 Pipeline crossing the Pasig River, located approximately 80 m from the southern end of the target section.

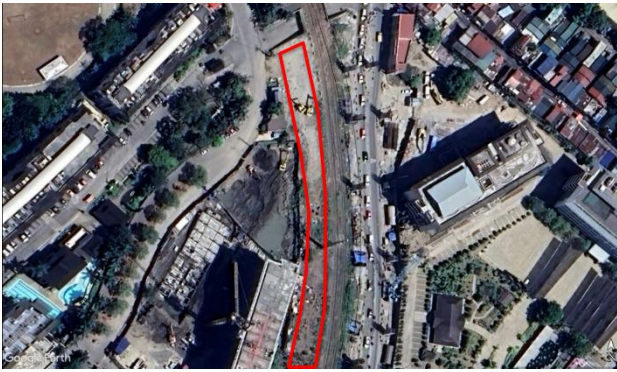
Figure 2.2.1 Northern section of the Pipeline segment under study, outlined in red.

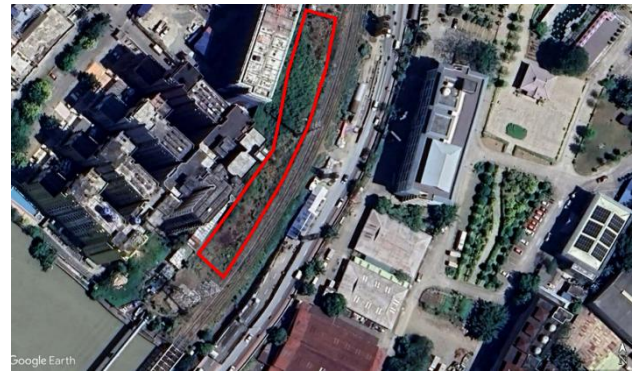
Figure 2.2.2 Southern section of the Pipeline segment under study, outlined in red.

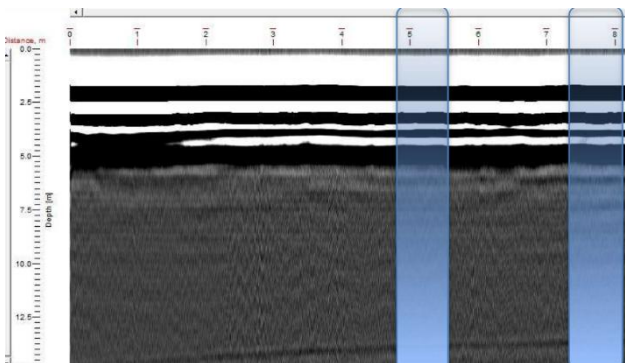
Figure 2.3.2.5 GPR Line 327 showing double anomaly located at 5.8 m and 9.2 m from the Railway

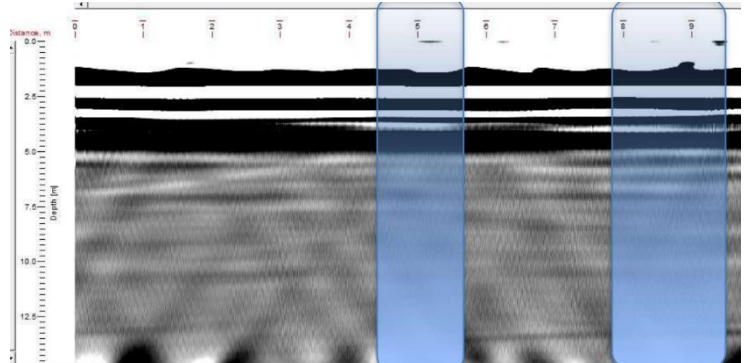
Figure 2.3.2.6 GPR Line 326 showing double anomaly located at 5.6 m and 9.6 m from the Railway

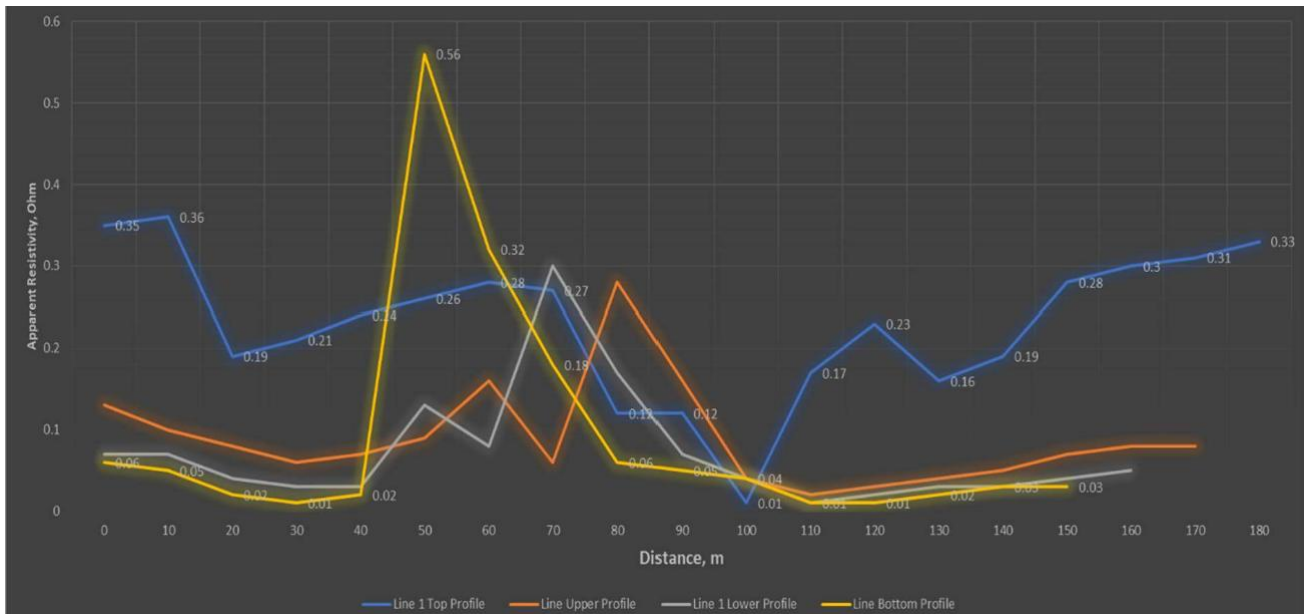
Figure 3.2.1.2 Apparent Resistance values in Ohm across the Survey Line 1 for four profiles beneath the surface, presented in line graph form.
