# IAC News : Special Issue No.10

## Quick Report on the 2016 Kumamoto Earthquake

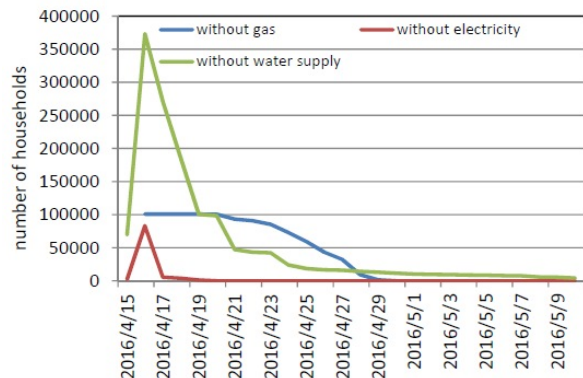
The earthquakes on April 14 and 16 brought about severe damage to lifelines such as electricity, gas and water supply (Fig. 4). About 200,000 households temporarily lost power, and as of the night of April 16, about 80,000 households were still without power, which was recovered by April 20. Regarding water supply, up to 370,000 households were without water until one week later when water could be supplied to 90% of the households; however, about 4,000 households were still without water as of May 10. City gas supply was suspended for about 100,000 households, but was gradually restored from April 20 and then completely

Fig. 4: Restoration status of city gas, electricity and water supply

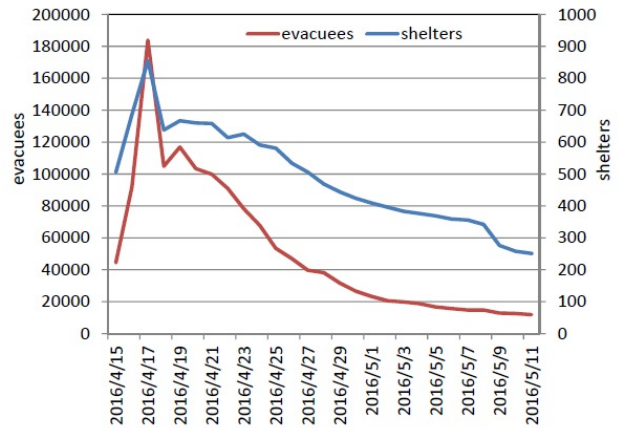
restored by the end of April. Also, many general waste disposal facilities, which are closely linked to daily life, were damaged. Due to damaged combustion furnaces, four garbage disposal facilities were unusable for a prolonged time, making it difficult to dispose of disaster waste. As shown in Fig. 5, the number of evacuees, which once exceeded 180,000, decreased with the restoration of water, gas and electricity supply; however, about 10,000 people were still living in 251 shelters as of May 11.

Fig. 5: Changes in the number of evacuees and shelters
